Post Flood Report: Record Rainfall and Flooding Events During September 2013 in New Mexico, Southeastern Colorado and Far West Texas

**US Army Corps
of Engineers**®
Albuquerque District

November 2014

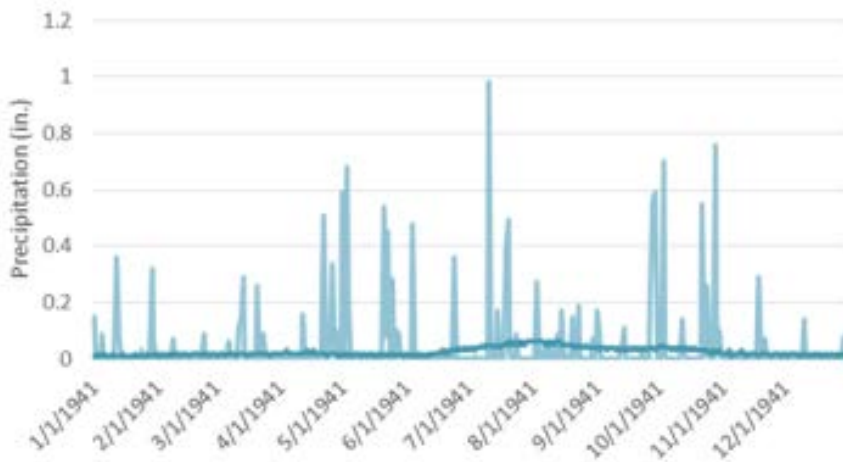
Figure 18 - Precipitation in Albuquerque during 1941 (light blue line) and average precipitation for those dates (darker blue-green line) (NOAA/NWS 2013u).

Following the drought of 1931-1941, snowfall during the winter and spring of 1941 was the heaviest on record at some locations. Abnormal temperatures and rainfall during the runoff period, combined with excessive snow cover, produced a flood having a maximum peak of 22,500 cfs at the Otowi gage on 16 May and 24,600 cfs at San Marcial on 17 May. The duration of the flood was in excess of two months, with flows exceeding 20,000 cfs for five days at Otowi and ten days at San Marcial. The peak discharge on the Rio Chama at Chamita, which was partially controlled by El Vado Reservoir, was 9,910 cfs on 14 May. The next year, spring flooding occurred due to snowmelt in the mountainous regions of northern New Mexico and southern Colorado and augmented by rain in April. Although flow above 5,000 cfs occurred over a longer period of time than during the 1941 flood, the peaks were lower. A peak of 16,400 cfs at Otowi was caused by rainfall. A peak of 18,400 cfs was measured at San Marcial on 26 April. 1941 is unique in having had significantly above average precipitation throughout the year, earning it the title of “wettest year on record” (NOAA/NWS 2013u).

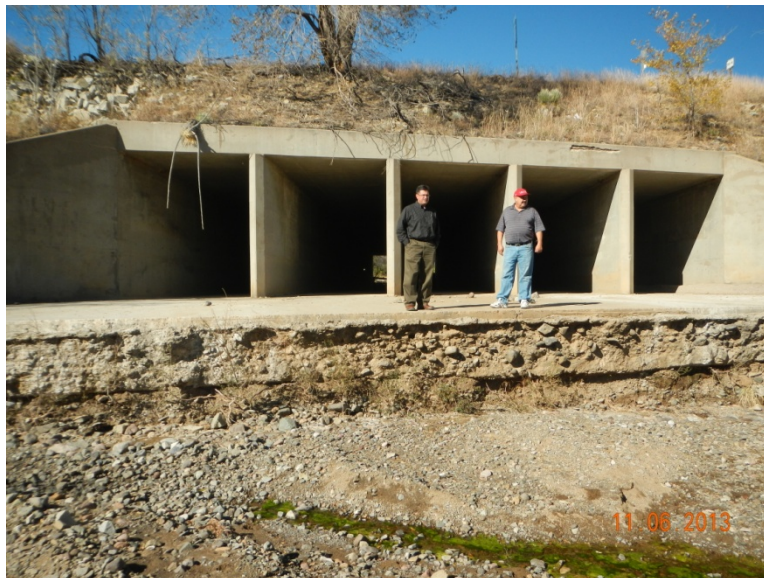
Figure 20 - Damage at the Village of Santa Clara, NM (Grant County), included 5 feet of downcutting immediately downstream of this box culvert.

Flooding in Santa Clara Canyon filled and breached detention ponds up canyon, compromising their future flood mitigation effects. The flood waters moved downstream and the stage gage recorded a maximum stage of 9.59 ft. Based on observed high water marks along the Creek and downstream of the Highway 30 box culverts, this series of floods at a minimum equaled the peak flow rates of the 20 July 2013 flood event (for which a separate FEMA Disaster Declaration was issued), with a much larger volume of sustained flood flows.

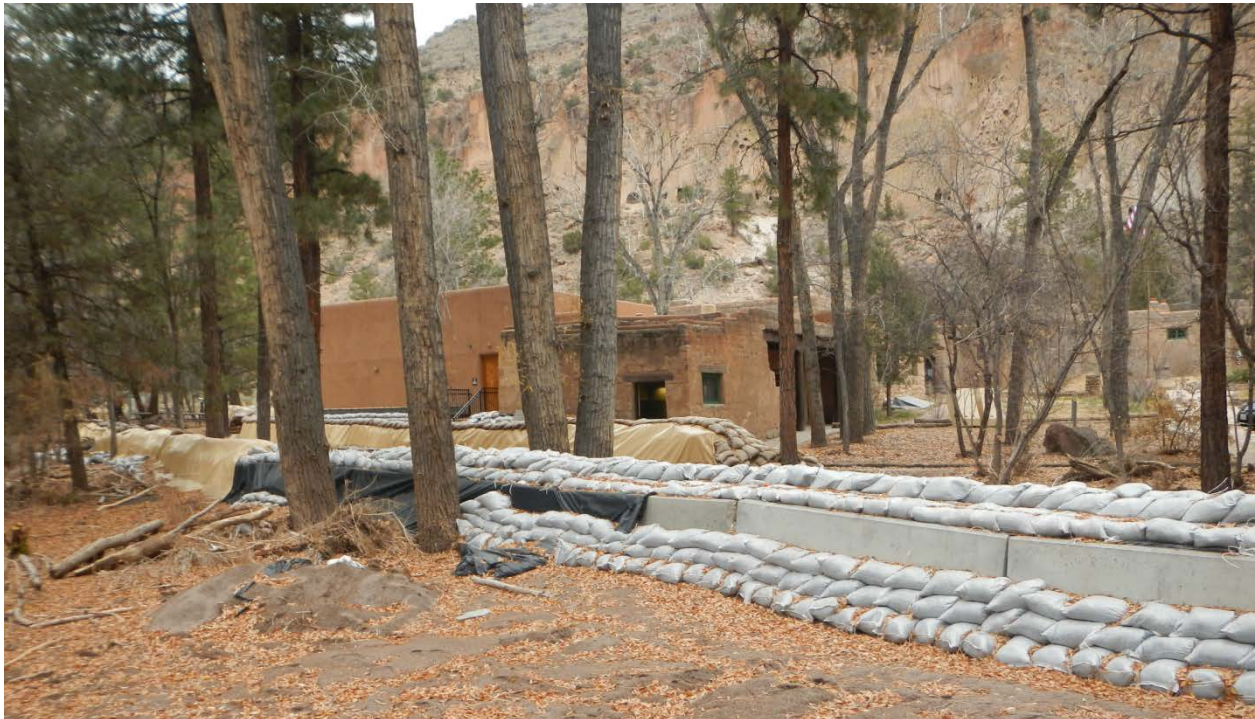
Figure 21 - Sandbags and Jersey barriers used to prevent flood damage to historic buildings at Bandelier National Monument.

Moving south from Santa Clara Pueblo along the eastern Jemez Mountains, severe flooding also occurred several times in Frijoles Canyon (data from Bandelier National Monument, personal communication, fall 2013). The largest flood occurred on the morning of 13 September, producing a discharge of approximately 9,000 cfs in the Lower Frijoles Canyon area. Erosion and aggradation occurred along Frijoles Creek, and significant debris transport was evident. Flooding overtopped access roads and trails in the Lower Canyon and damaged some developed roads. Damage to historic (CCC) structures at the Visitor Center and damage to the campground was prevented through extensive flood proofing efforts (Figure 20).

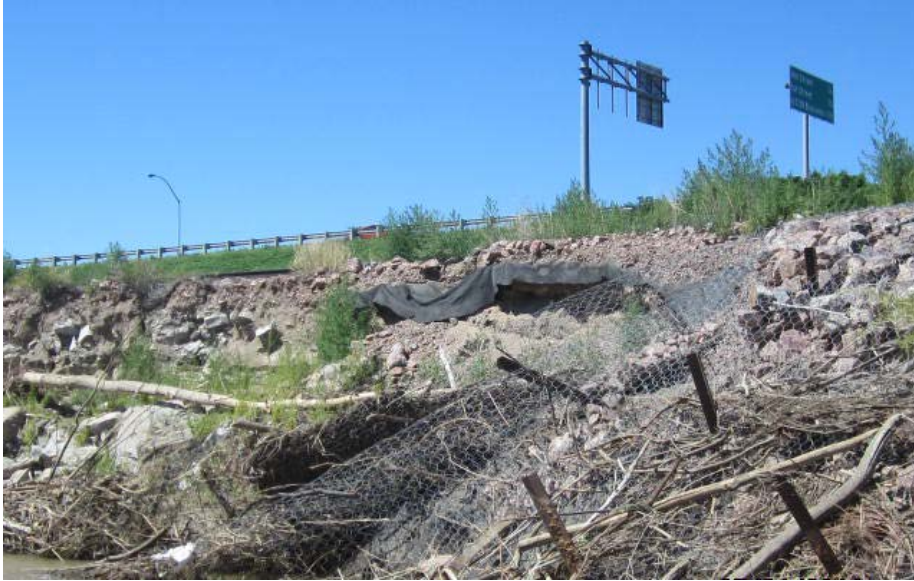
Figure 31 - Damage to railroad embankment along Fountain Creek in Colorado.

On September 13, 2013, the City of Pueblo sustained damages from flooding on Fountain Creek. The majority of flow originated in the Fountain Creek watershed in the Colorado Springs, Colorado and Security, Colorado areas. The peak discharge on Fountain Creek during that event was 11,800 cfs. This is the 5th highest peak flow on record at the USGS gage near the confluence with the Arkansas River. The excessive runoff from this rainfall event caused structural failure to a previously constructed wire-wrapped riprap embankment protection on the west bank of the Fountain Creek, near 13th Street and Interstate 25 (Figure 29). As a result, erosion threatens the western embankment of the flood control project as well as a Union Pacific Railroad mainline located along the embankment (U.S. Army Corps of Engineers (USACE) 2014b).

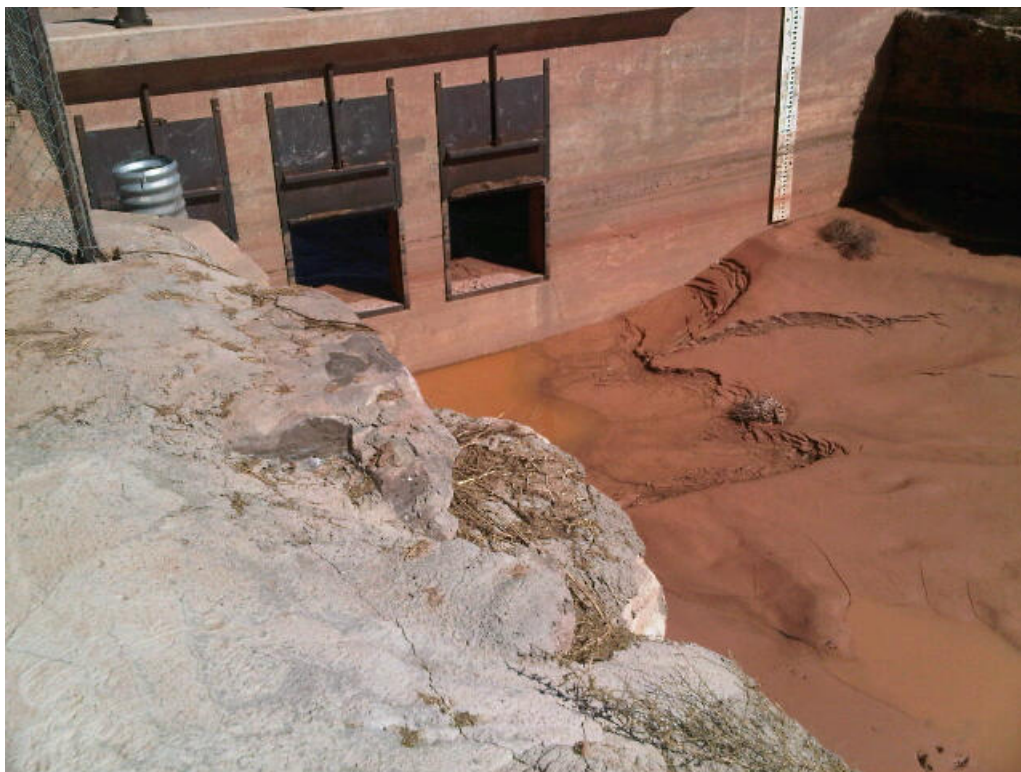
Figure 32 - Flood damage to a diversion structure in Many Farms, Navajo Nation (courtesy of Rose Whitehair).

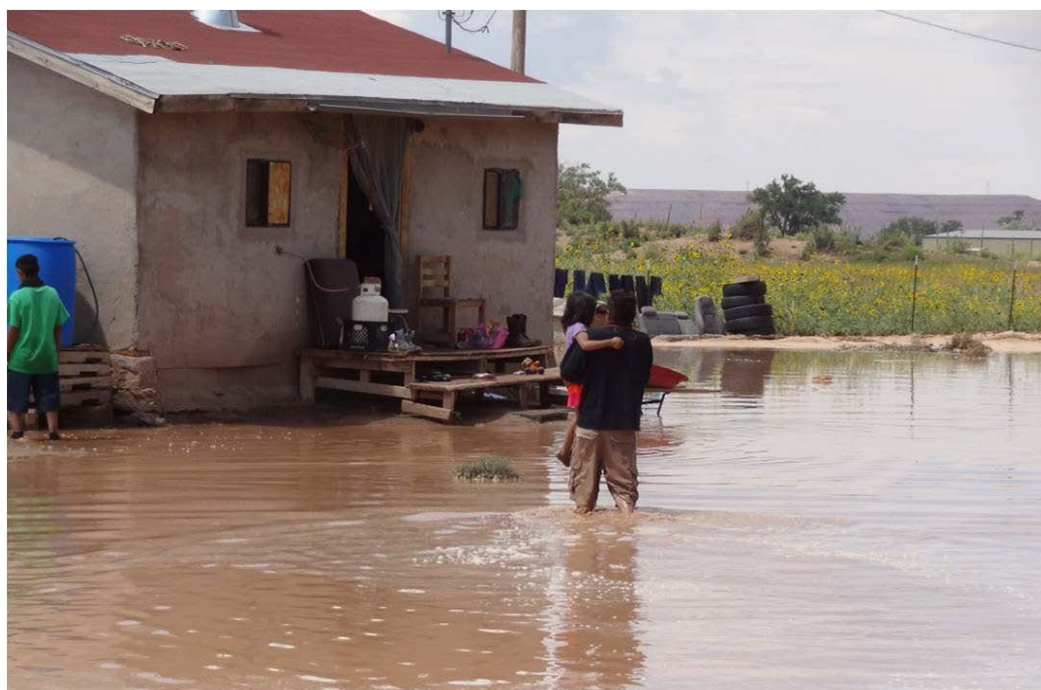
Figure 33 - Flood damage to a home in Chinle, Navajo Nation, Arizona (courtesy of Rose Whitehair).

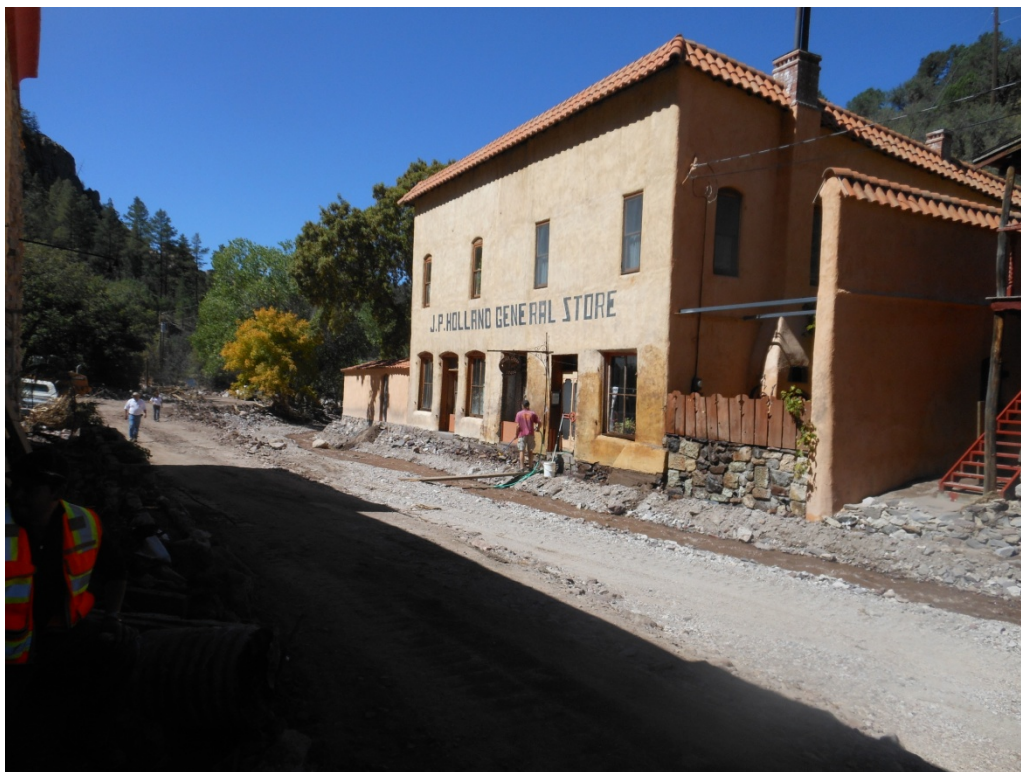
Figure 35 - High water mark on the general store, Mogollon, NM.

Flooding in the Lower Colorado River Tributary Headwaters area occurred primarily due to heavy rains on the Whitewater Baldy burn scar. Some areas received as much as 8 to 10 in of precipitation over the period 9-18 September. Precipitation events that caused significant flooding occurred on 9-10 September and again on the night of 14-15 September. Flooding was also reported in Pietown, and Reserve between 12 and 15 September (NOAA/NWS 2013c).

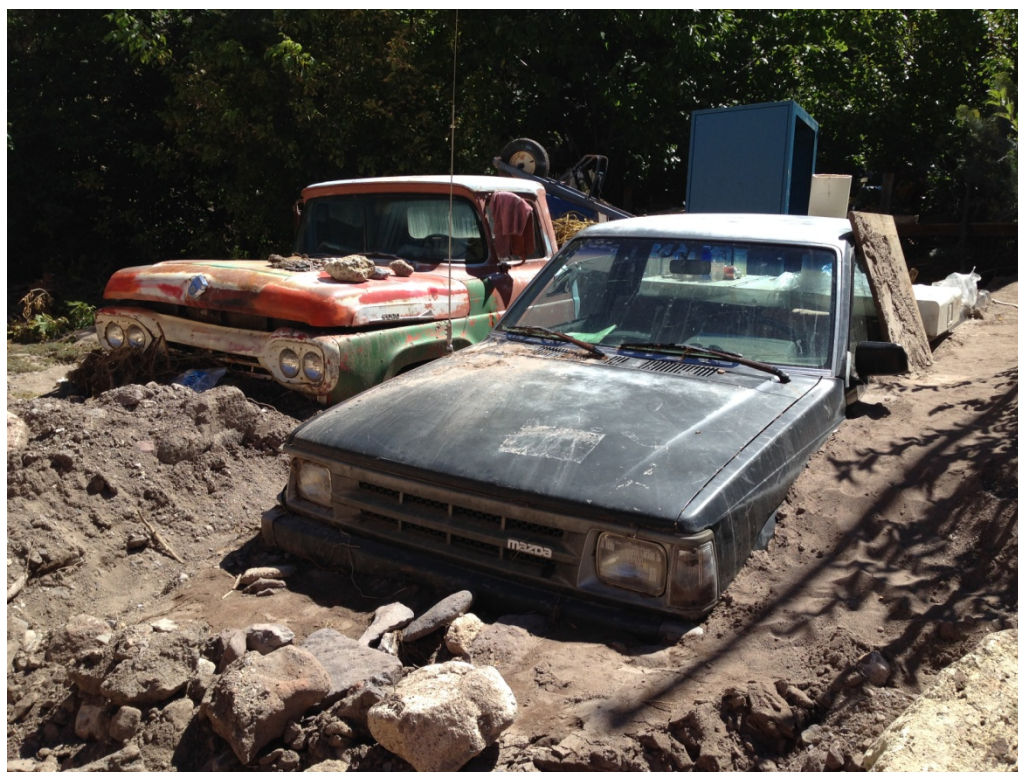
Figure 36 - Cars buried in sediment following a September 2013 flood in Mogollon, NM.

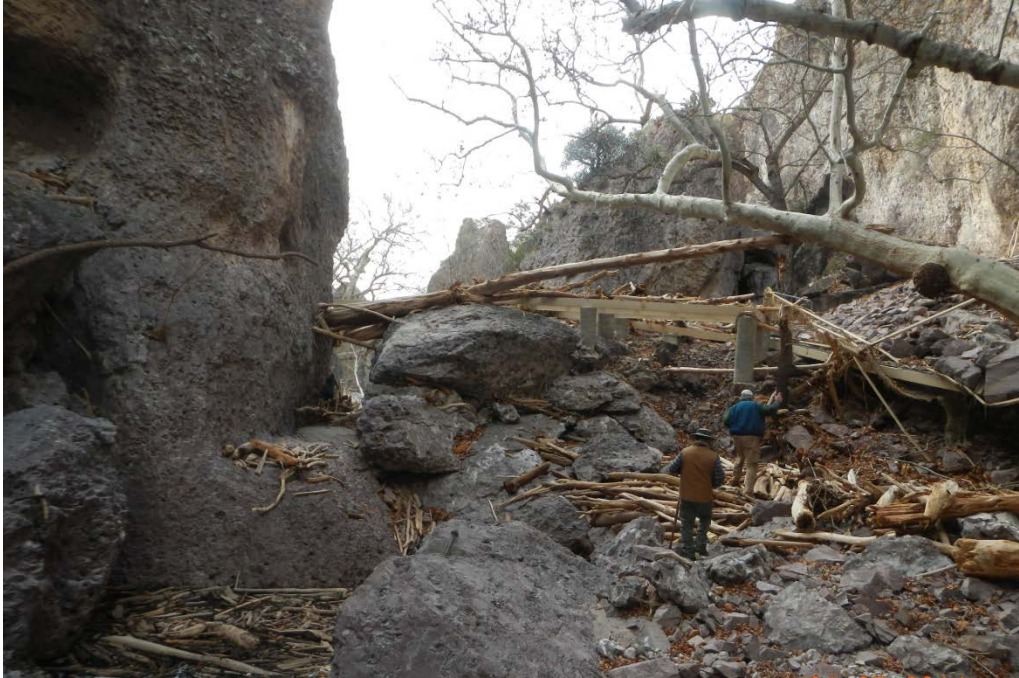
Figure 37 - Flood damage to the Catwalk, a popular tourist destination near Glenwood, NM.

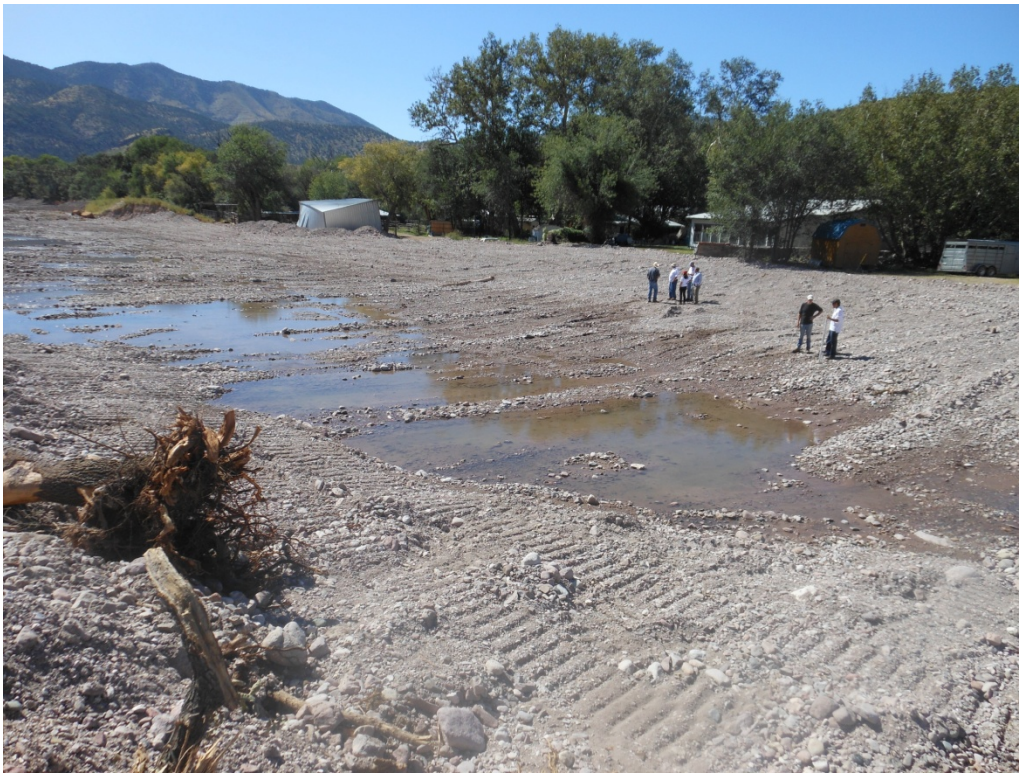
Figure 38 – Channel work along Whitewater Creek, near Glenwood, NM, following a September 2013 flood event.

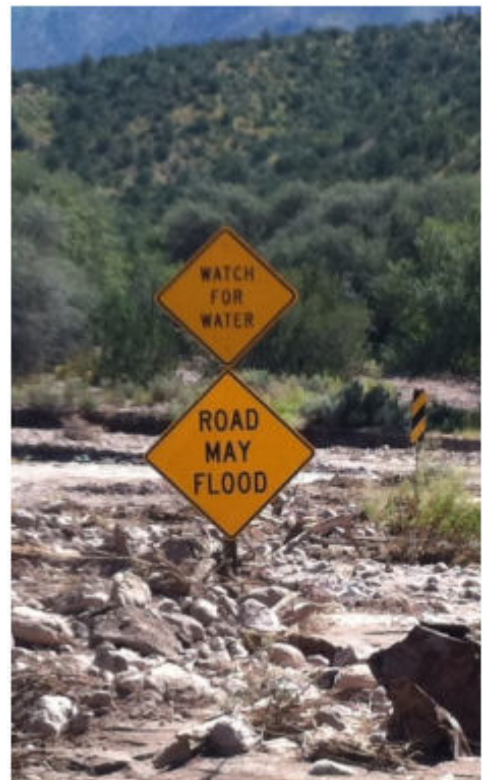
Total rainfall amounts over the 9-day period averaged 3 to 6 inches and in some areas just over 10 inches. Several river gauges reported record to near record crests and in a couple cases gauges were completely destroyed. Emergency management reported disastrous impacts to residential, commercial, and transportation infrastructure across northern and central New Mexico. Significant coverage of this event was broadcast by local and national media outlets. Social media coverage of the event was extraordinary as residents and visitors to the region shared valuable feedback with the National Weather Service. A total of 12 New Mexico counties, 4 cities and towns, and 4 pueblos, including the Navajo Nation, were included in a statewide disaster declaration. The New Mexico State Emergency Operations Center was in command at Level 2 operations for several days.

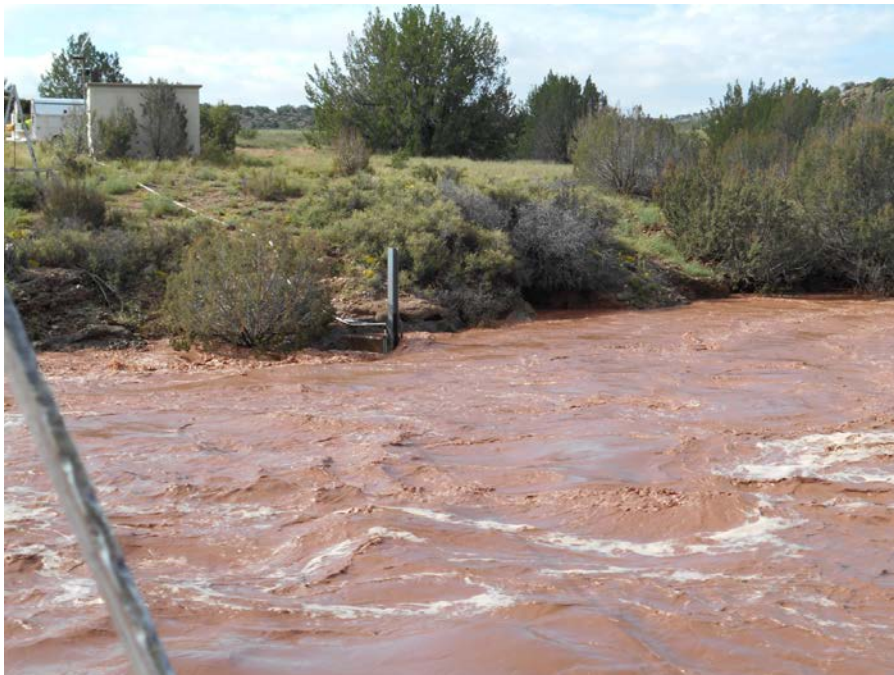
Figure 1: Pecos River below Cañon del Uta (08382600) staff gage, September, 2013. (Photograph by M. Carlson.)

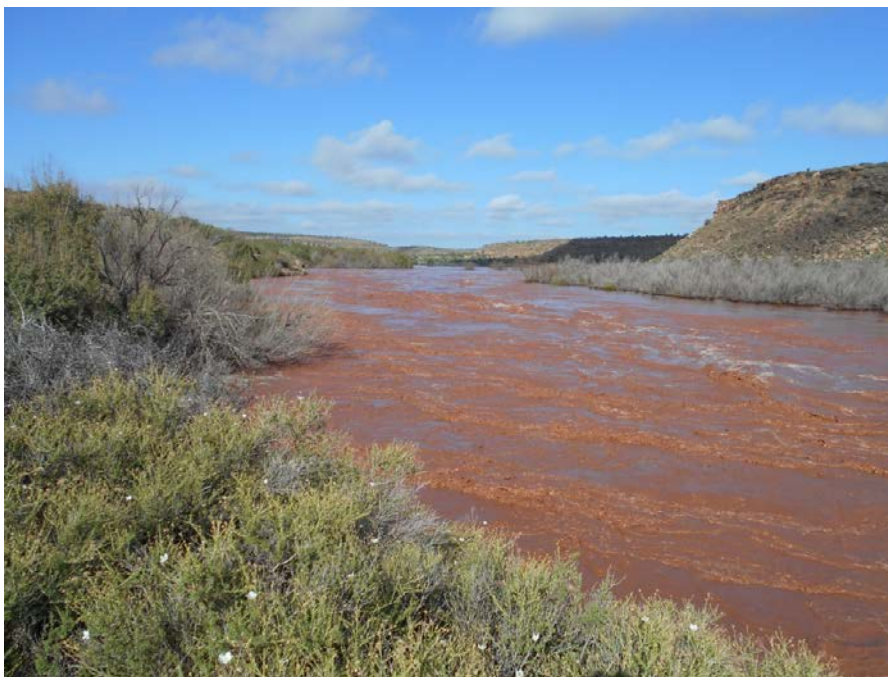
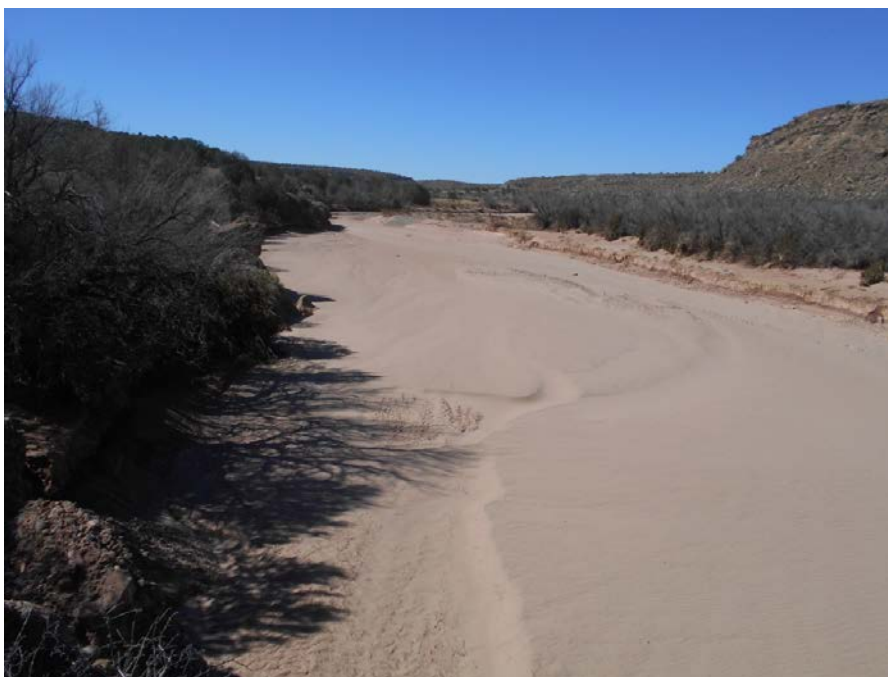
Figure 2: Pecos River upstream from the streamgage at Cañon del Uta. *A*, September 2013. *B*, October, 2013. (Photographs by M. Carlson.)

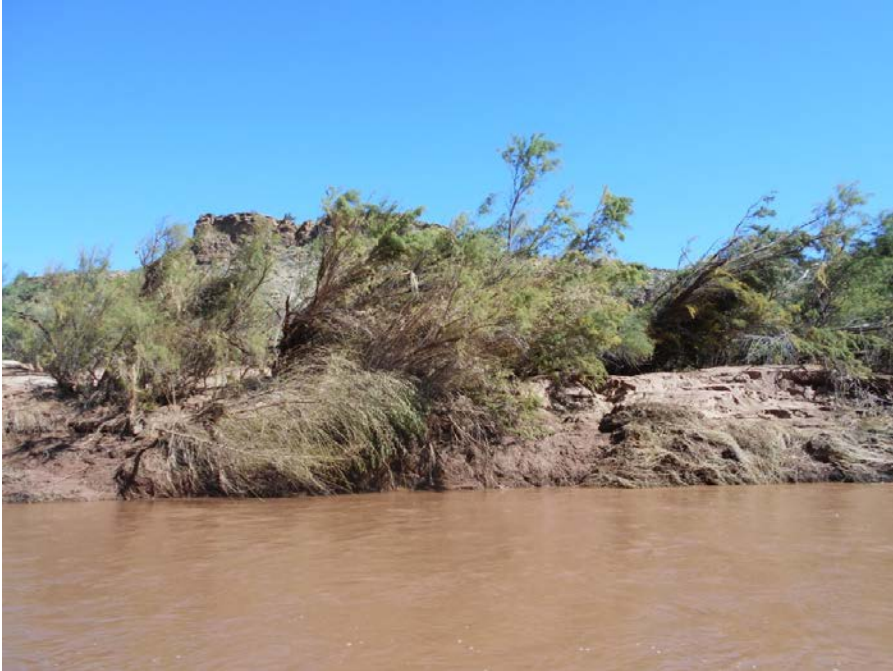
Figure 3: Pecos River above Santa Rosa Lake (08382650) showing affects of overbank flooding on riparian vegetation, September, 2013. (Photograph by M. Carlson.)

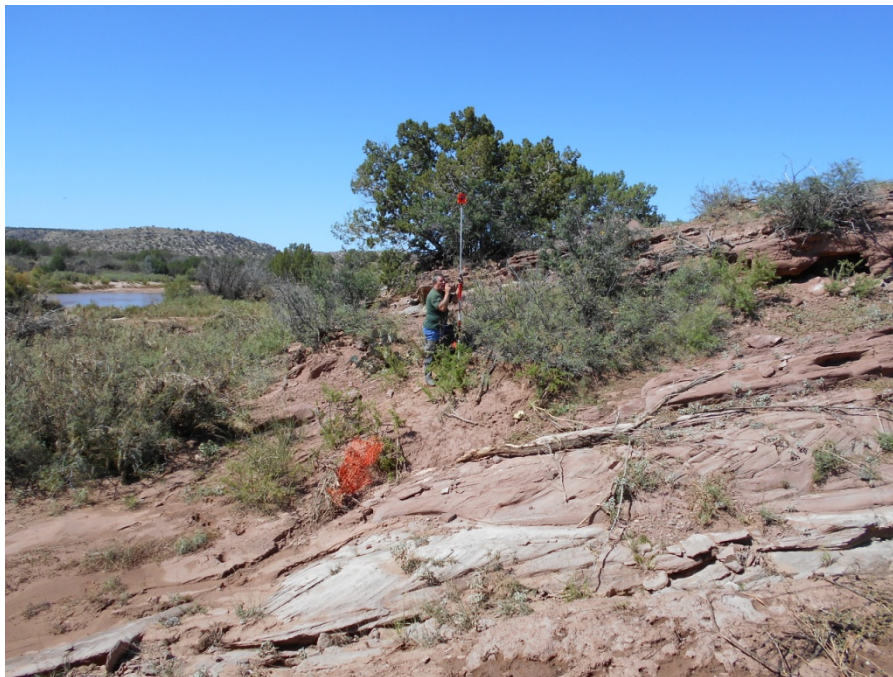
Figure 4: Pecos River near Puerto de Luna (08383500), September, 2013. Survey rod marks location of high-water mark. Pecos River is to the left in the photograph. (Photograph by M. Carlson.)

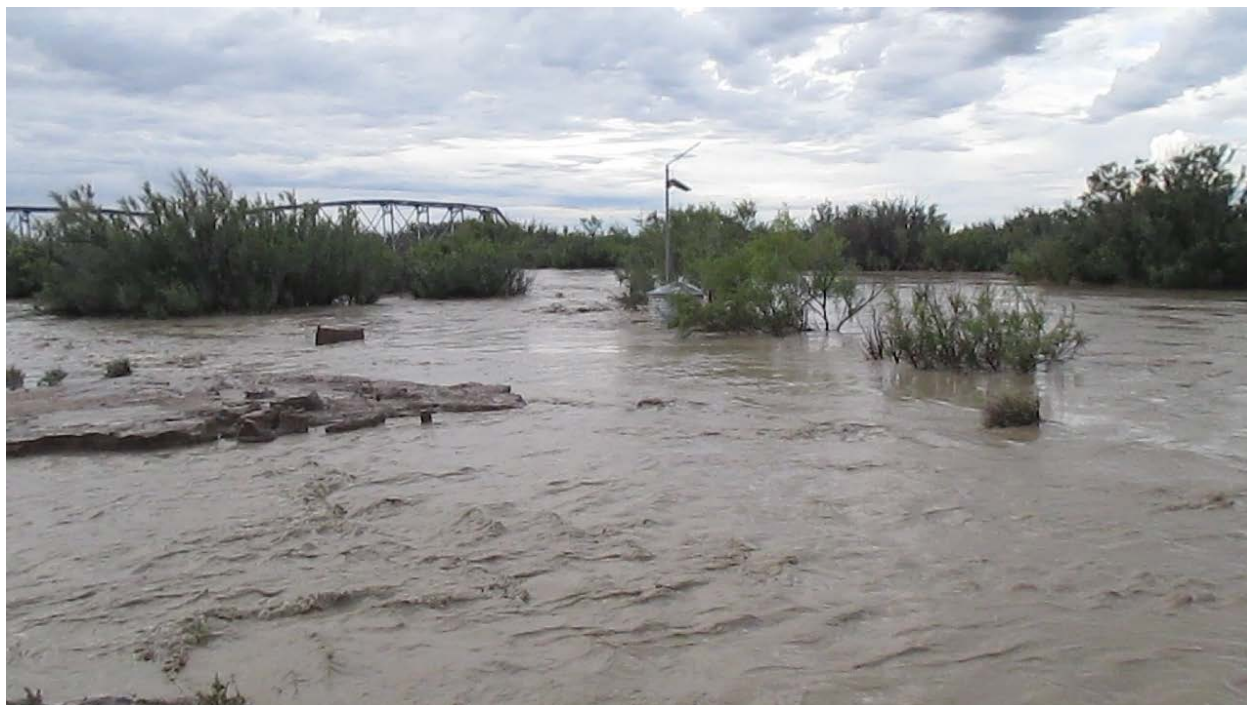
Figure 5. Rio Puerco near Bernardo (08353000), September 16, 2013. Flood peak occurred near midnight. Submerged gage house is seen in center of photograph. (Photograph by J. Cederberg).

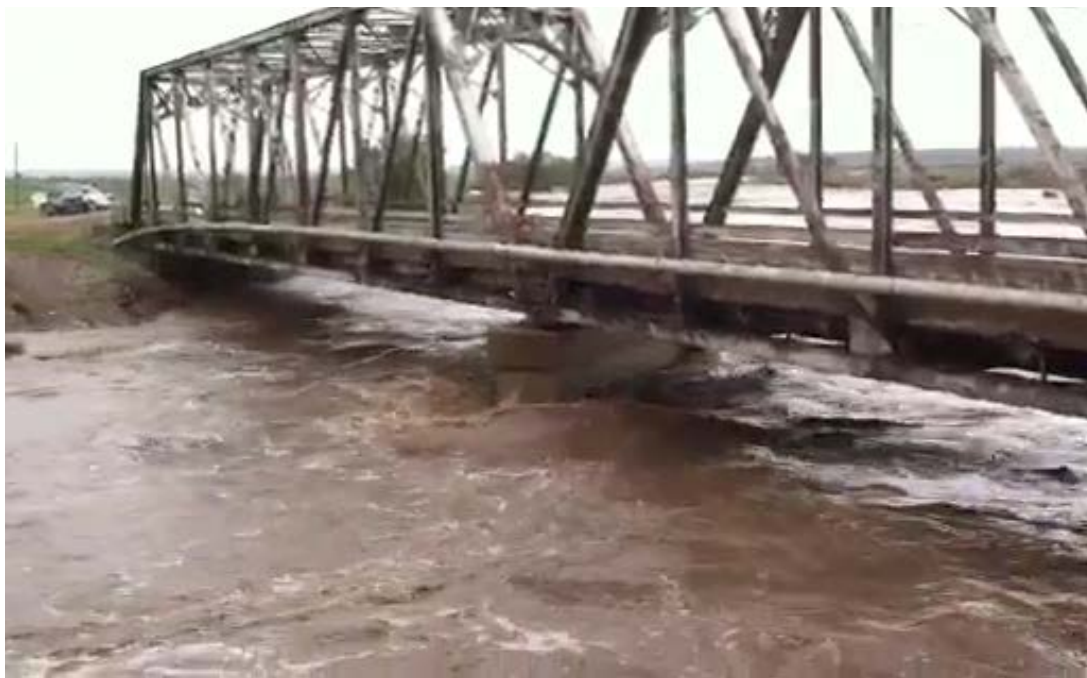
Figure 6: Rio Felix at Old Highway Bridge near Hagerman, NM (08394500), September 12, 2013. (Photograph by A. McGlone.)

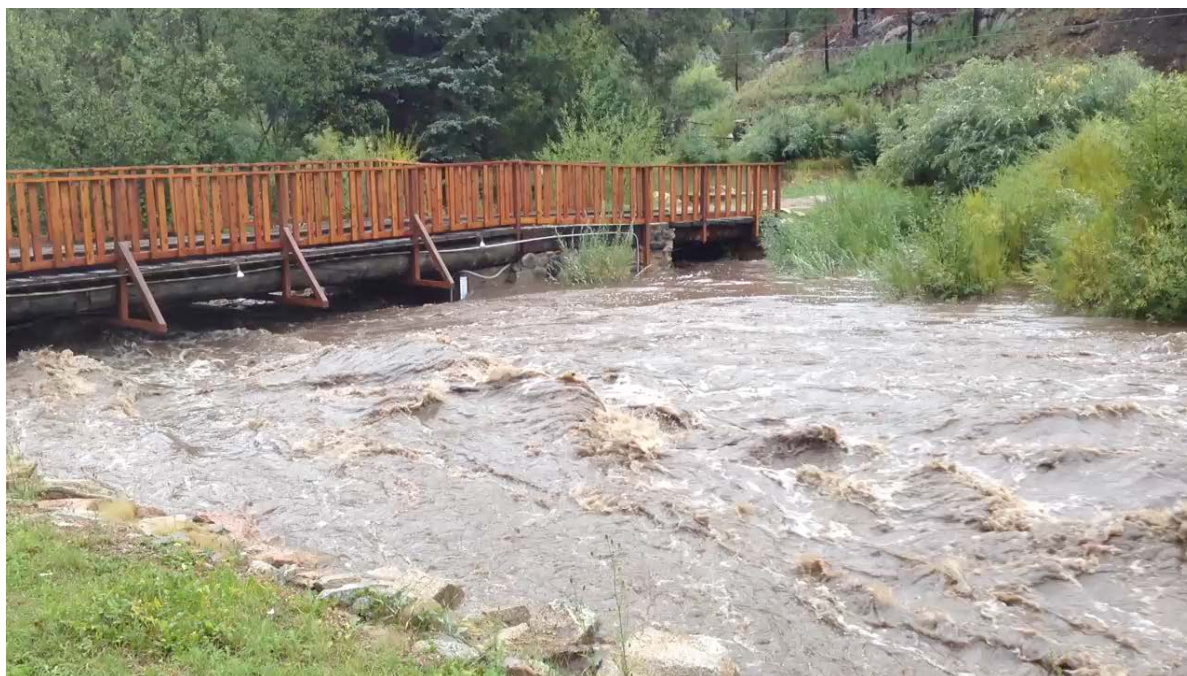
Figure 7. Rio Puerco near Pecos (08378500), September 13, 2013. (Photograph by J. Cederberg).
