UNM Earth Data Analysis Center
New Mexico State Cooperating Technical Partner, FEMA Region 6

Mapping Activity Statement 006

Automated Landslide Hazard Detection
September 2017

LiDAR Derived Landslide Products

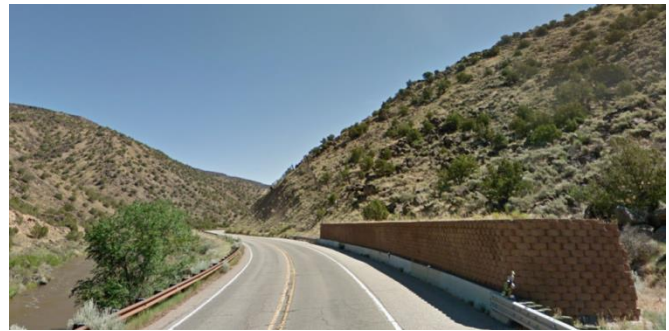
Figure 4 - Classified slopes (yellow [value 1] and red [value 2]) along NM68 in Taos Canyon on the left and the same area from Google Street View (June 2016) on the right.

This data was then simplified to represent the major slope breaks for landslide processes noted above with slopes below 20 degrees classified with a value of “0”, slopes between 20 and 45 degrees classified with a value of “1”, and slopes 45 degrees or above classified with a value of “2” (Figure 5). Thus with this reclassified slope map value “1” represents areas at risk for debris flows, debris avalanches, earth flows, and rotational slides and with values of “2” represent areas susceptible to rock topples, rock falls, and rock flows.

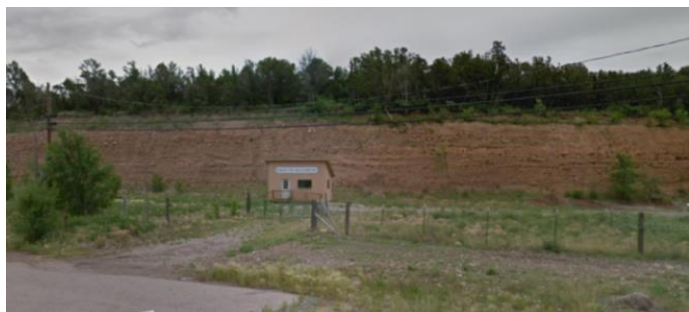
Figure 7 - An example of the classified curvature (red) in the lower center in Ruidoso on the left and on the right the same cliff edge from Google Street View (June 2015).

A floating point image ranging from -100 to 100 was created for both study areas. In surveying the study areas it was found that values above 10 or below -10 best mapped these vertical terrain features. Therefore, a new image was created where all values below -10 and above 10 were classified as value “1” and all other values were classified as “0” (Figure 7).

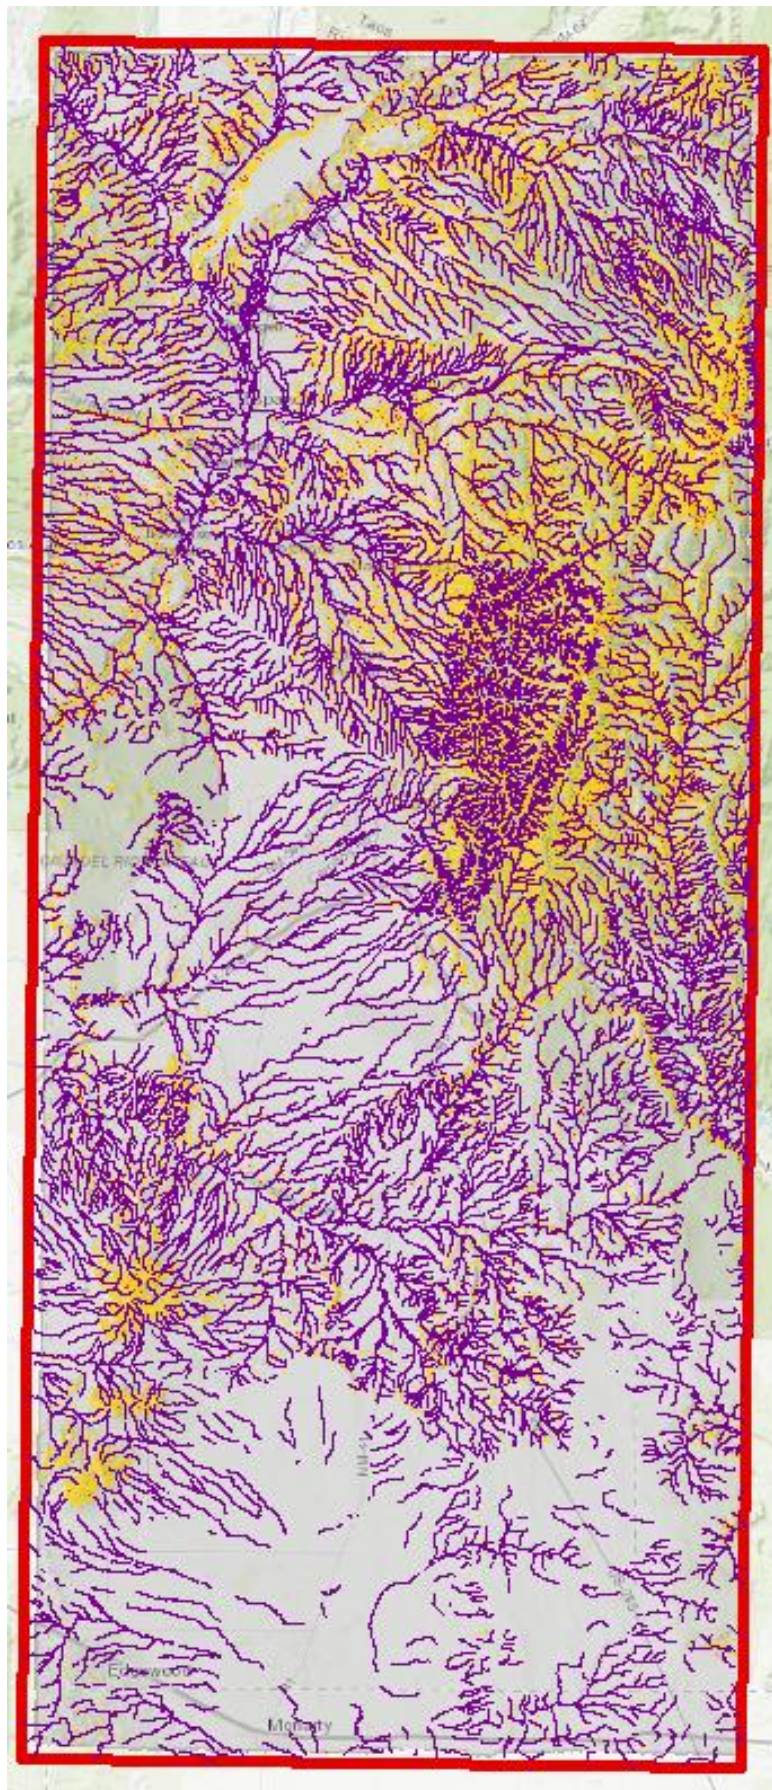
Figure 12 - The mudflow susceptible drainages overlain on the classified slope map for the Santa Fe County study area.

The NHD HUC-8 flowlines for the Santa Fe County (parts of the Upper Rio Grande, Rio Chama, Rio Grande-Santa Fe, Western Estancia, Pecos Headwaters, and Pintada Arroyo sub-basins) and the Rio Hondo watershed (Rio Hondo) study areas were download form the USGS NHD data site. These were overlain on to the results and all drainages covering potential risk areas or directly downstream were selected – (Figure 12 – Santa Fe County, Figure 13 – Rio Hondo HUC-8 Watershed). These were considered potential mudflow susceptible drainages given the proper conditions (e.g. wildfires, insect herbivory epidemic, timbering operations).

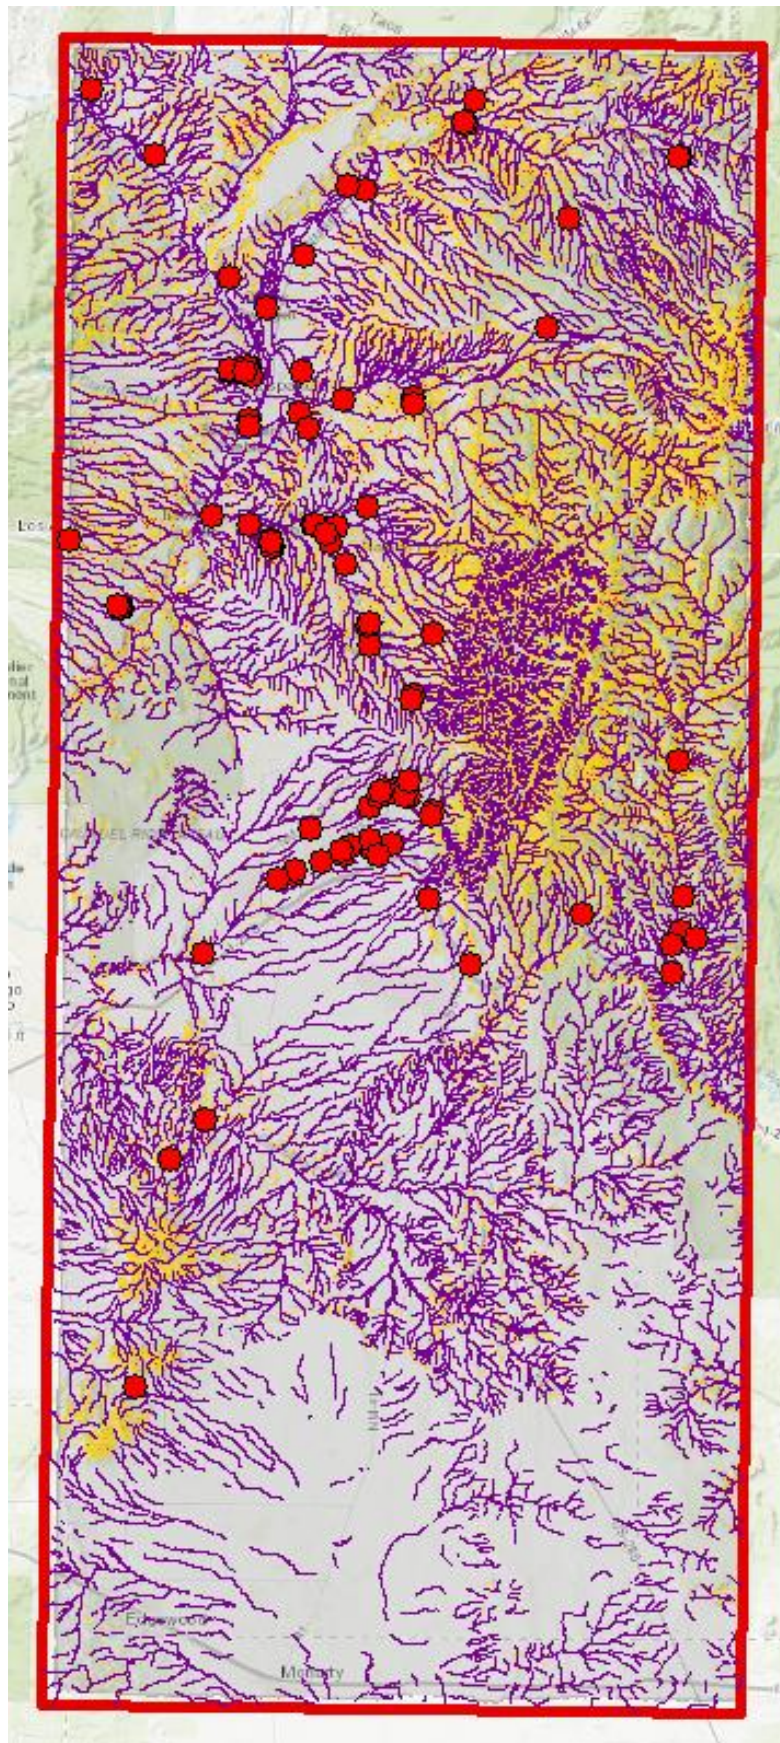
Figure 14 – The community anchor sites (red dots) with the mudflow susceptible drainages overlain on the classified slope map for the Santa Fe County study area.

The potential landslide map and the potential mudflow susceptible drainages were then combined the state's Community Anchor Site Assessment (CASA). The CASA datasets contains point locations of known community anchor sites – emergency operations centers, fire stations, government community resources, health centers, higher education facilities, law enforcement facilities, libraries, medical facilities, and K-12 public schools. A manual inspection of each CASA location was conducted to ascertain whether or not it was adjacent to an area of landslide risk.
